Docket No. 217 – Development and Management Plan Inspection

Northeast Utilities Service Company Certificate of Environmental Compatibility and Public Need for the construction of a 345-kV electric transmission line and reconstruction of an existing 115-kV electric transmission line between Connecticut Light and Power Company's Plumtree Substation in Bethel, through the towns of Redding, Weston, and Wilton, and to the Norwalk Substation in Norwalk, Connecticut.

Date: April 19, 2005

Location: 345kV XLPE Component

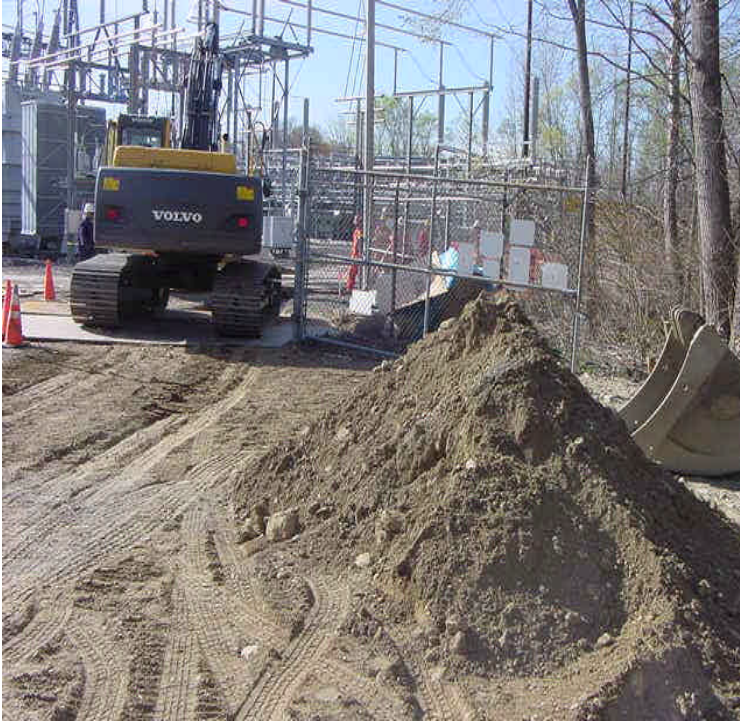
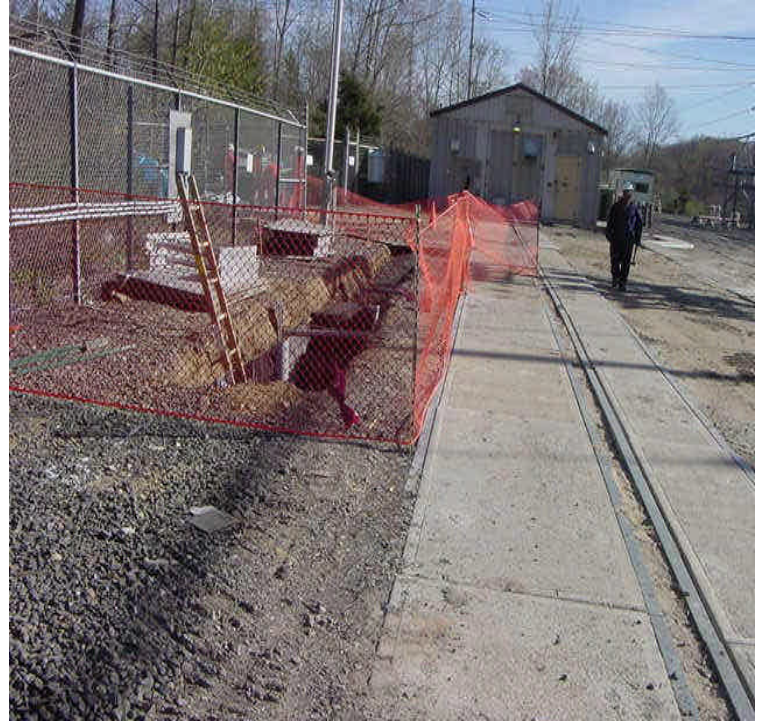
345kV XLPE (Walnut Hill Rd): Photo on the left shows a view of the end of the work leading into Plumtree Substation. Photo on the right shows a view of the trenching within the station yard.
4/19/06

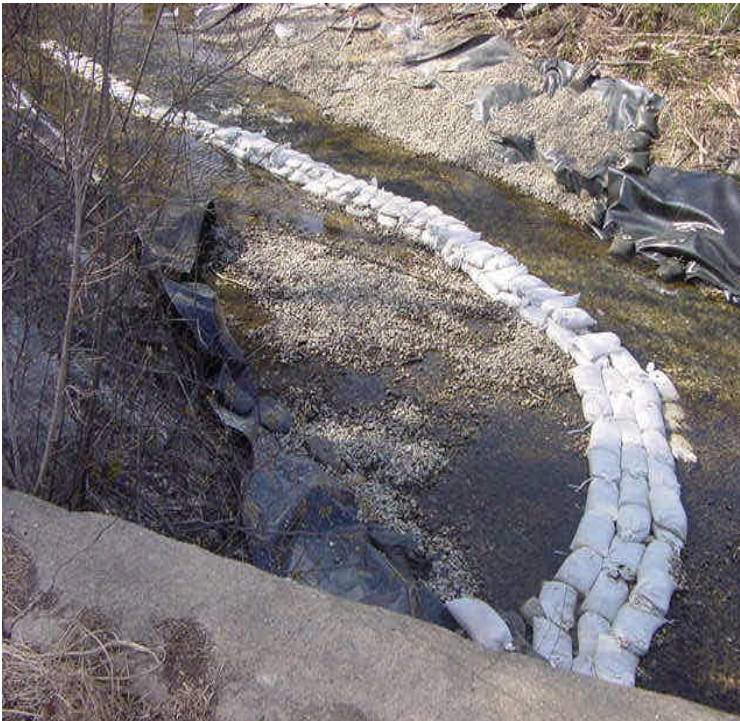
Areas of Inspection	Observation	Recommended Action	Corrective Action
Inland Wetland and Watercourse encroachment and mitigation	-East Swamp Brook crosses under Plumtrees Rd. A large plastic liner is in place across the bed and up along the banks to keep water out of the bore trench. Additional stone was added and sand bags were installed in an attempt to divert the water. 4/6-4/19/06	- The stream continues to run clear. Be sure to remove the liner and restore the natural bed when work is complete. Watch the banks where soil was disturbed for any erosion. 2/16-4/19/06	-N/A at this time until the work is complete
State species of concern, threatened and endangered species	-The D&M plan and clearance letter states that state-listed species are not located in this work area. -However, a wood turtle was noted at Plumtree Substation last spring. 4/19/06	- N/A -345kV XLPE crews should also be performing daily walkthroughs before moving equipment in the morning. 4/19/06	-N/A

(Jack and Bore) Photo on the left shows the stream with the diversions remaining in place. Photo on the right shows a view of the operation at the J&B pad. 4/19/06

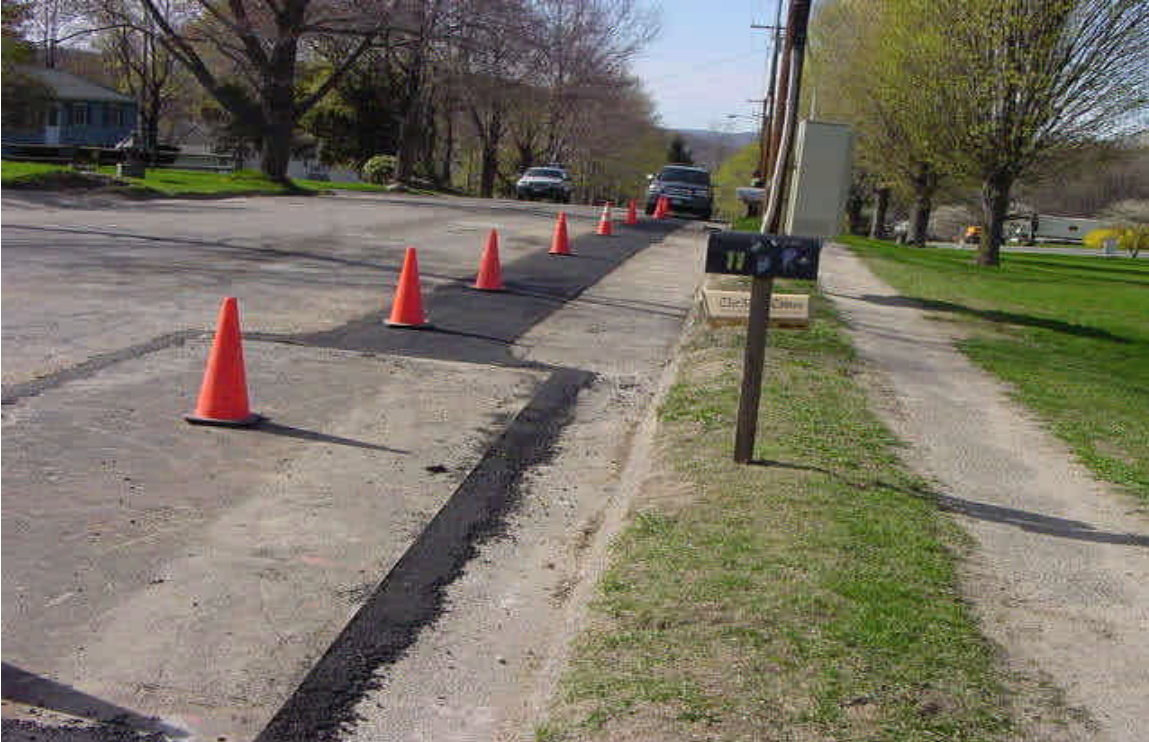
(Judd Ave) Photo shows a view of the completed trench near the intersection of Judd Ave and Whittlesey Drive. 4/19/06

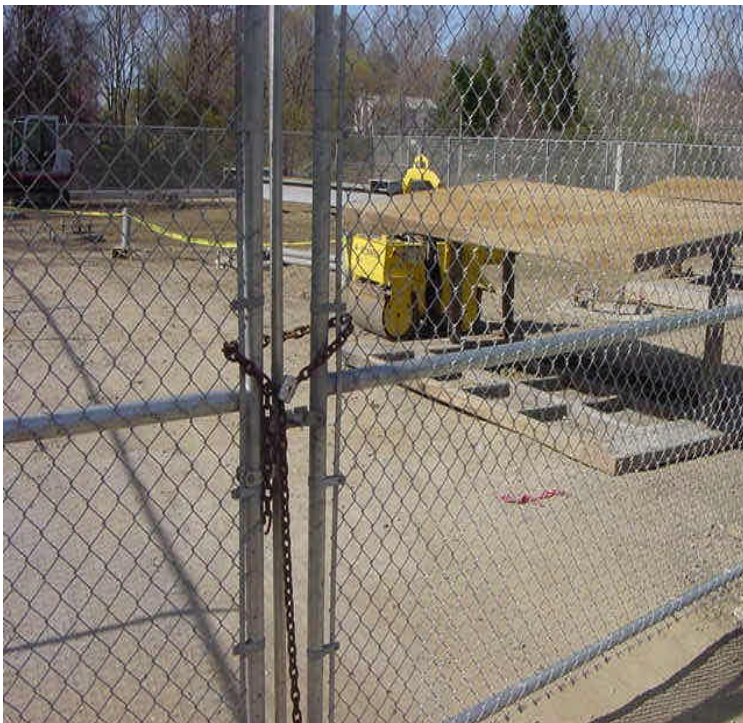
(Hoyts Hill): Photo on the left shows a view of the transition station pad where work had been completed for the time. Photo on the right shows a view of the recently restored slope where some new grass growth was noted. Evidence of equipment tracking was also noted in the wetland beyond the stone access. 4/19/06

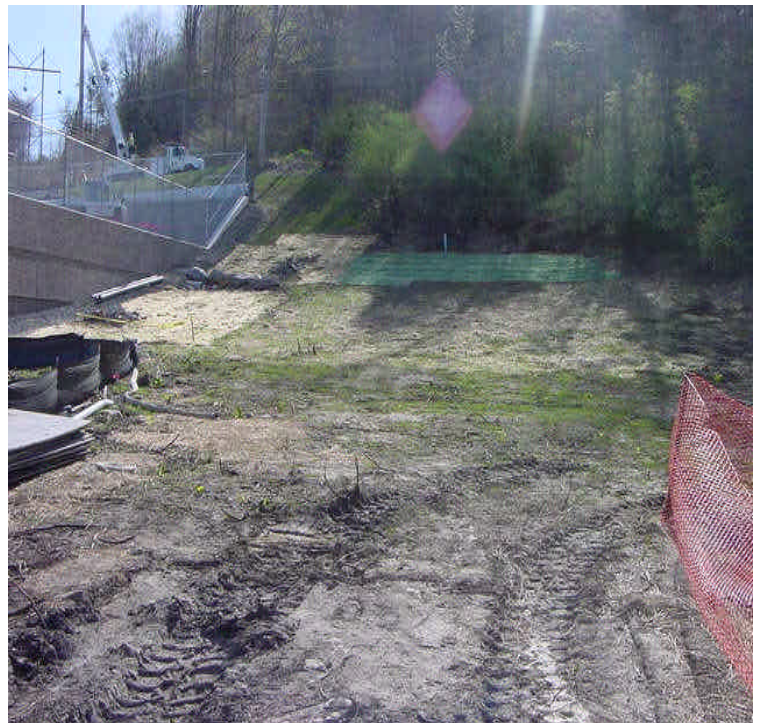
- Noticeable grass growth had occurred along the slope. 4/19/06	- None at this time, continue to monitor for stabilization. 4/19/06	- N/A (grass growth has occurred)
	-Materials were no longer noted stacked in the adjacent wetland. 4/19/06	-Continue to monitor. 4/19/06	-Materials were removed from the wetland.
	-Equipment tracking was noted in the wetland beyond the stone access where mats had previously been. 4/19/06	- Mats may have been removed prematurely. The wetland surface should be restored. 4/19/06
